# Manhole Inspection Summary

Manhole # S17A\_\_018MH

Insp Date: **7/3/08 3:46 PM**

**Location** Address: **800 WARWICK AVE**

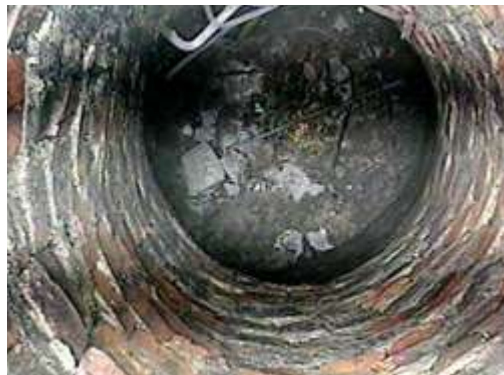
Location View

Condition: ☐ Sound ☐ Cracked ☐ Root Intrusion ☐ Deteriorated ☐ Leaks ☒ **Debris**

**Steps** Count: **3** Missing: **0** ☒ **Corroded**

STEPS CORRODED/DEBRIS IN CHANNEL

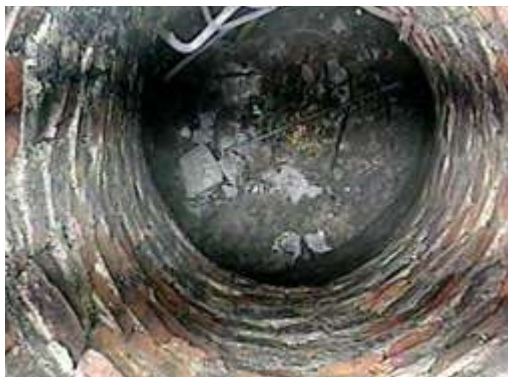
Top View

Condition: ☐ Sound ☒ **Cracked** ☐ Root Intrusion ☐ Loose Brick ☐ Deteriorated

CRACKED BARREL / CHANNEL  
DEBRIS

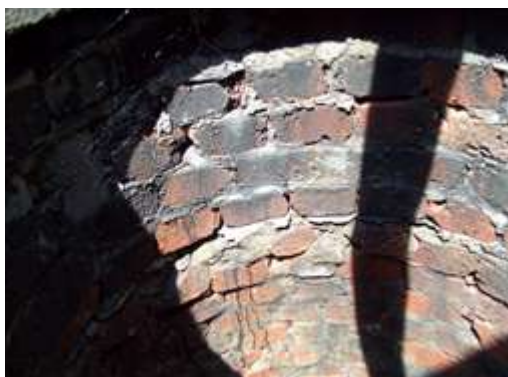
Defect 3

Condition: ☐ Sound ☒ **Cracked** ☐ Root Intrusion ☐ Loose Brick ☐ Deteriorated

CRACKED CORBEL

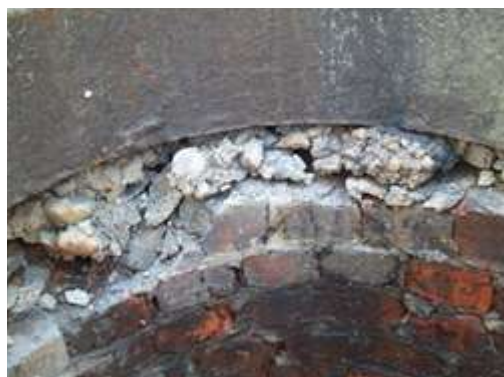
Defect 1

Condition: ☐ Sound ☐ Cracked ☐ Root Intrusion ☐ Loose Brick ☒ **Deteriorated**

CHIMNEY DETERIORATED

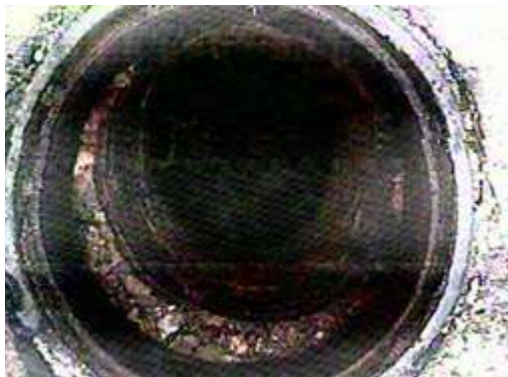
### Defect 3

**Frame** Offset: **2** (in.) Condition: ☒ Sound ☐ Cracked ☐ Leaks

FRAME OFFSET

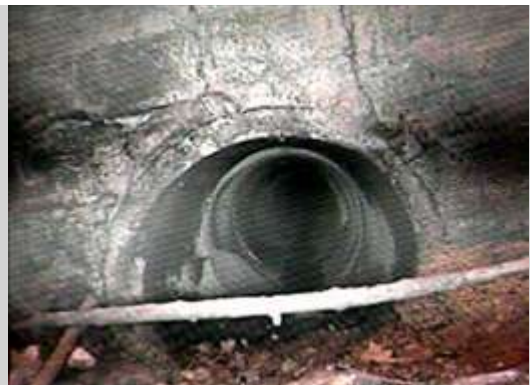
12 O'Clock Outflow

8 in. Circular Gravity Sewer  
Pipe Out @ 12 O'Clock

Pipe Material: **Clay** ☐ Pipe Lined

Invert Depth: **8.52** (ft.) Flow Characteristics: **None**

Infiltration: **None** Pipe Seal Cond: **Sound**
